DEPARTMENT OF TRANSPORTATION

Quality Assurance and Source Inspection

Contract #: 04-0120F4Cty: SF/ALA Rte: 80 PM: 13.2/13.9File #: 69.28**WELDING INSPECTION REPORT****Resident Engineer:**Pursell, Gary**Address:** 333 Burma Road**City:** Oakland, CA 94607**Report No:** WIR-010473**Date Inspected:** 04-Dec-2009**Project Name:** SAS Superstructure**OSM Arrival Time:** 1900**Prime Contractor:** American Bridge/Fluor Enterprises, a JV**OSM Departure Time:** 700**Contractor:** Zhenhua Port Machinery Company, Ltd (ZPMC), Changxing Island **Location:** Shanghai, China**CWI Name:** See Below**CWI Present:** Yes No**Inspected CWI report:** Yes No N/A**Rod Oven in Use:** Yes No N/A**Electrode to specification:** Yes No N/A**Weld Procedures Followed:** Yes No N/A**Qualified Welders:** Yes No N/A**Verified Joint Fit-up:** Yes No N/A**Approved Drawings:** Yes No N/A**Approved WPS:** Yes No N/A**Delayed / Cancelled:** Yes No N/A**Bridge No:** 34-0006**Component:** OBG and Tower**Summary of Items Observed:**

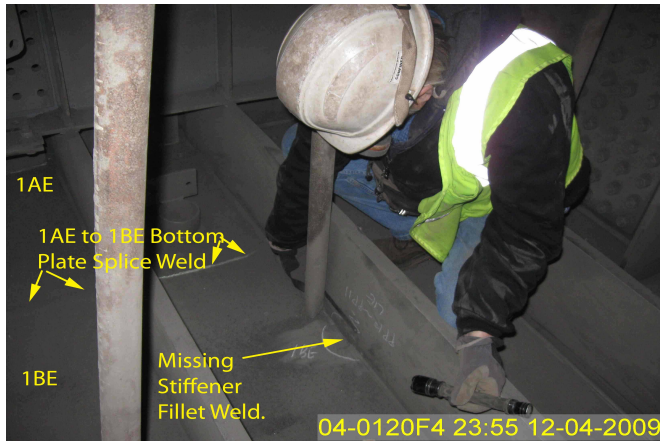
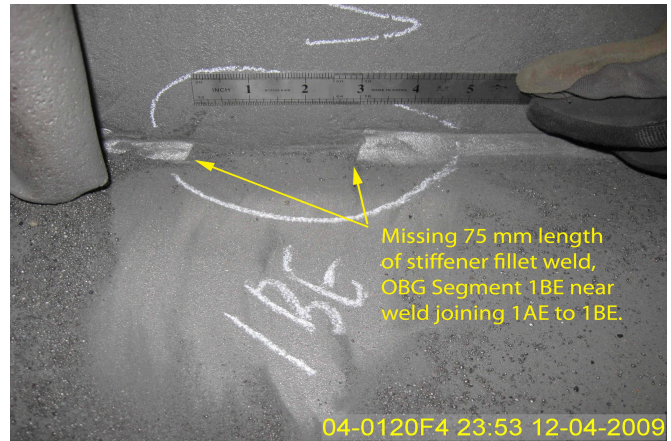
ZPMC QC Paint Inspector informed this QA Inspector that at 2145 hours in blast shop #4 Caltrans QA Inspection personnel are requested to carry out visual inspections of surface preparation of the bottom plate in OBG lift 1E. This QA Inspector and Caltrans QA Inspector Mr. George Goulet performed random visual inspections of the exterior end of OBG Segment 1AAE for a distance of approximately 1 meter as measured from the bottom of the OBG in the center and on the south side and the interior bottom plate of 1AE and 1BE between panel points 8.5 and 11. ZPMC recently performed weld repairs of the segment splice welds and due to removal of the coatings in certain locations, ZPMC has utilized grit blast equipment to remove all the paint from the interior bottom plate in these locations and ZPMC intends to paint it a second time. This QA Inspector visually observed approximately five locations that require grinding to resolve visual shallow nicks and scrapes. ABF observed and marked one stiffener plate fillet weld that is missing the weld for a distance of approximately 75 mm near panel point 10.5

approximately 400 mms from the butt weld joining segment 1AE and 1BE. ABF identified this area as needing to be welded. The areas were marked with colored chalk and ZPMC has a worker using a grinder to remove the areas that had been marked as being visually unacceptable. ZPMC has a magnetic particle (MT) inspector available to perform Magnetic Particle Testing (MT) inspections of the arc strike removal areas. ZPMC paint inspection personnel informed this QA Inspector that ZPMC is going to grit blast the interior surfaces a second time. See the photographs below showing the missing fillet weld.
